**BRETTS WHARF**  
*HAMILTON, BRISBANE CITY*  
**SITE CLEAN UP ASSESSMENT**  
**JUNE 2020**  
**AUTHOR: SABRINA ELIATAMBY**

AUSTRALIAN  
MARINE DEBRIS INITIATIVE

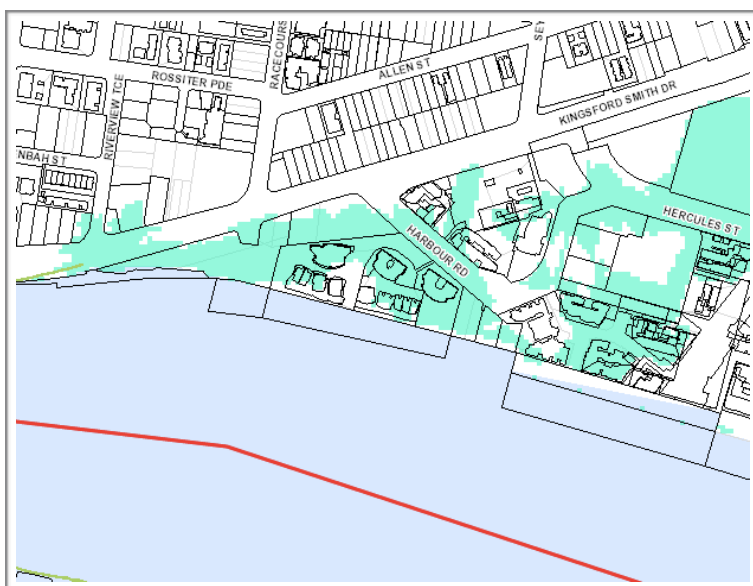
**Figure 2:** Medium storm-tide inundation area (Source: Brisbane City Council, 2014)

Located on the Northern side of the Brisbane River, Bretts Wharf (Figure 1) serves the Brisbane suburb of Hamilton. A 150m stretch of river bank at the location (*Latitude -27.4399; Longitude 153.0638*) was cleaned up by Tangaroa Blue Foundation volunteers in June 2020. The site area is subject to medium and high storm tide inundation (Figure 2 & 3). Much of the site is inundated during high tide, and is shown to collect litter as the tide goes out.

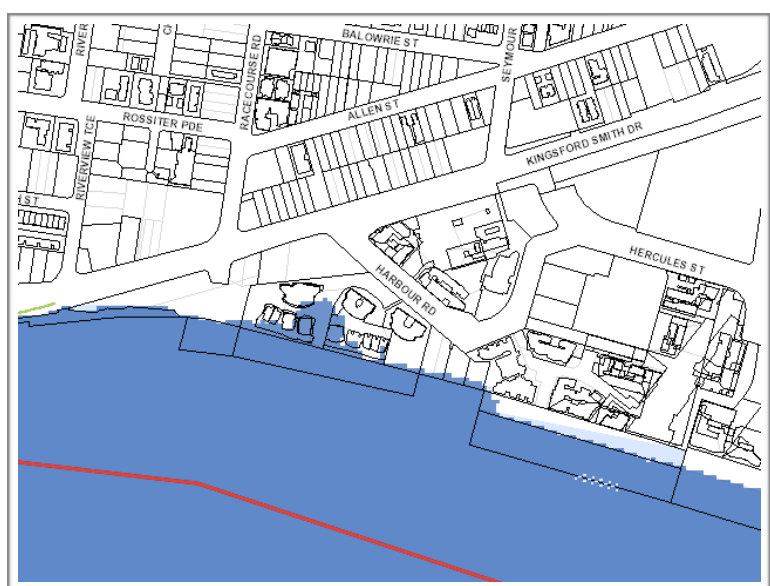
**Figure 3:** High storm-tide inundation area (Source: Brisbane City Council, 2014)

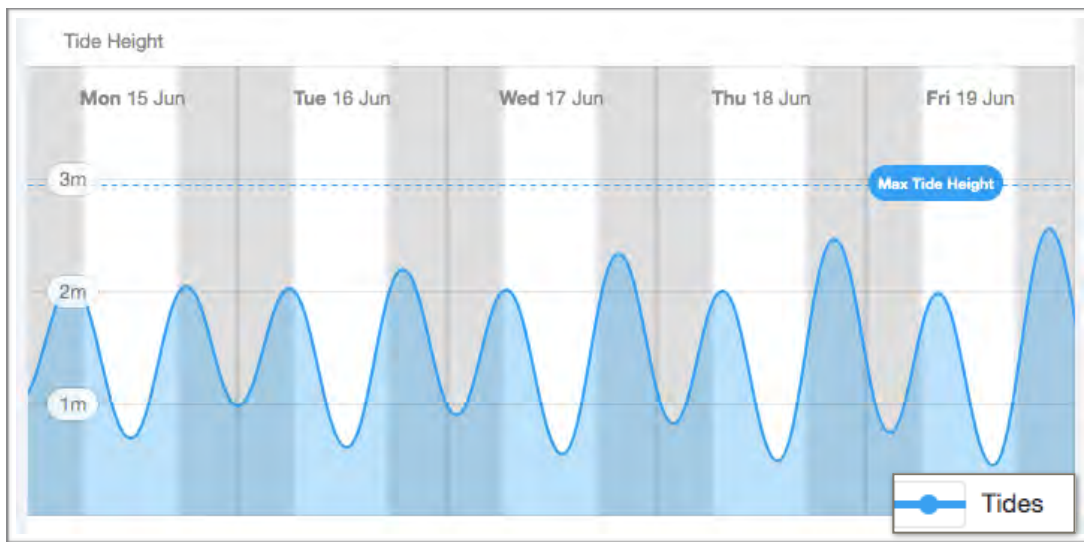
Figure 5: Tide Heights, Bretts Wharf Terminal (15/06/20 - 19/06/20); (Source: WillyWeather, 2020)

Rainfall and tidal conditions were observed during the site clean up period to examine the impact of these variables in correspondence to the quantity of debris washed ashore. Tide heights and tide points were considered during 15/06/20 - 19/06/20 and 22/06/20 when the site was revisited for monitoring purposes. Figure 5 shows a gradual increase in tide high points over the 5 day period, with a maximum of 2.06m on Monday, 15th June and a maximum of 2.55m on Friday, 19th June. The site was monitored during the morning of Monday 22nd June, when a maximum tide height of 1.94m was recorded at the station. Figure 7 shows higher than average rainfall event recording 11.4 mm on 15th June and 5.2mm observed on 19th June. An insignificant amount of rainfall (1.2mm) was reported on 22nd June.

The highest volume of litter was collected on the first day of the clean up with 1105 items amounting to 11kg. The rainfall event of 11.4mm on the day was coupled with a relatively higher tide of 2.06m. In contrast, when the site was revisited on the 22nd of June, there was less than 2mm of rainfall recorded on the day, along with a lower tide of 1.94m, and there was a significant decrease in litter observed, with comparatively low volumes. The results highlight that there is positive correlation between rainfall events, tide levels and overall quantities of debris washed ashore.

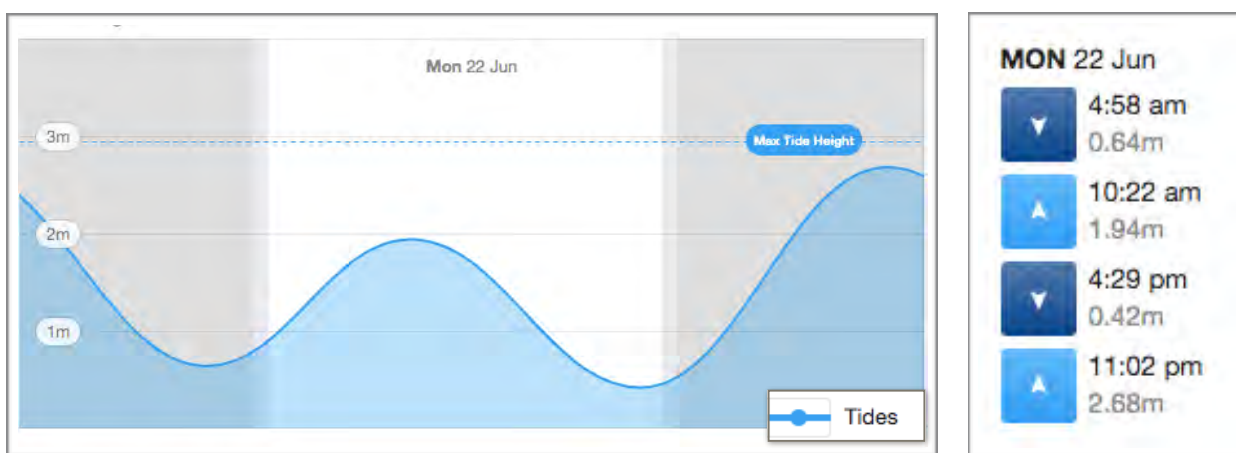
Figure 6: Tide Heights, Bretts Wharf Terminal (22/06/20); (Source: WillyWeather, 2020)

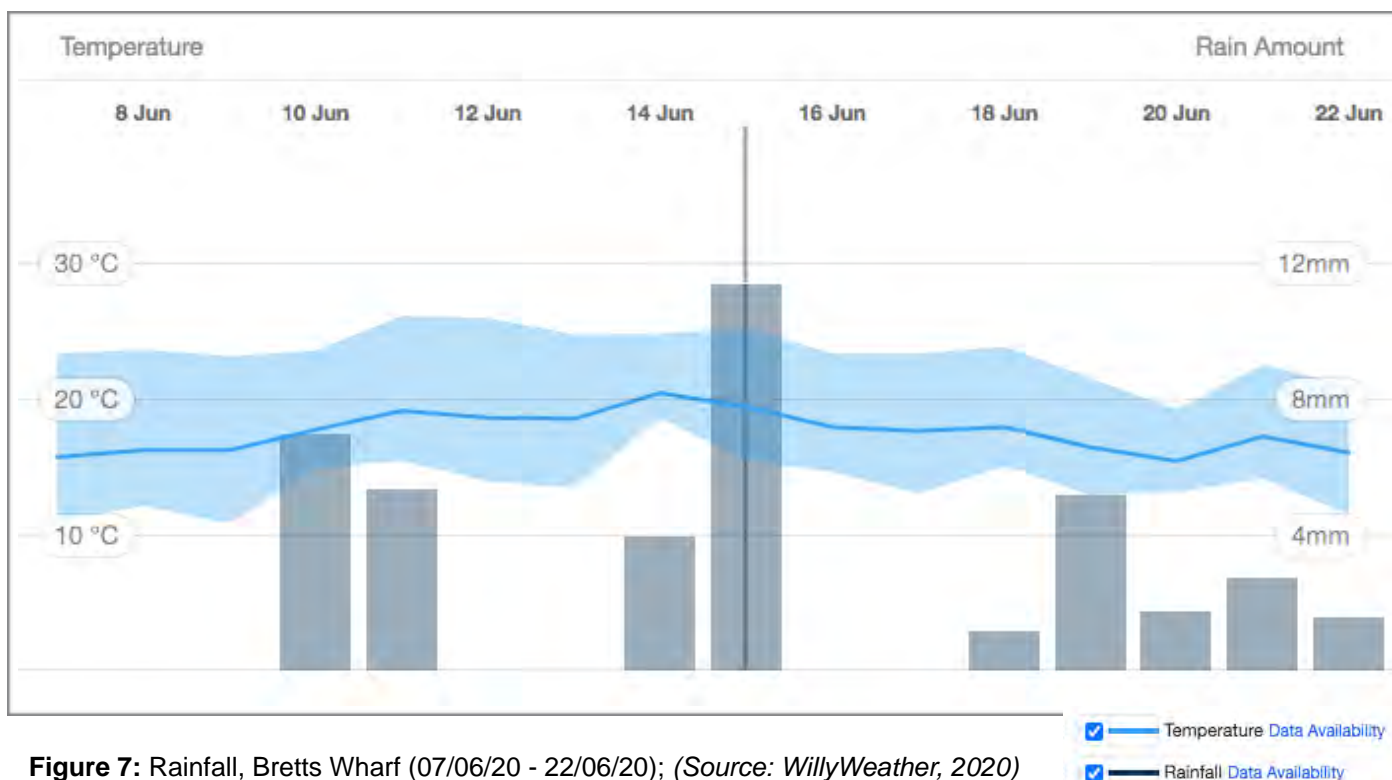
Figure 7: Rainfall, Bretts Wharf (07/06/20 - 22/06/20); (Source: WillyWeather, 2020)

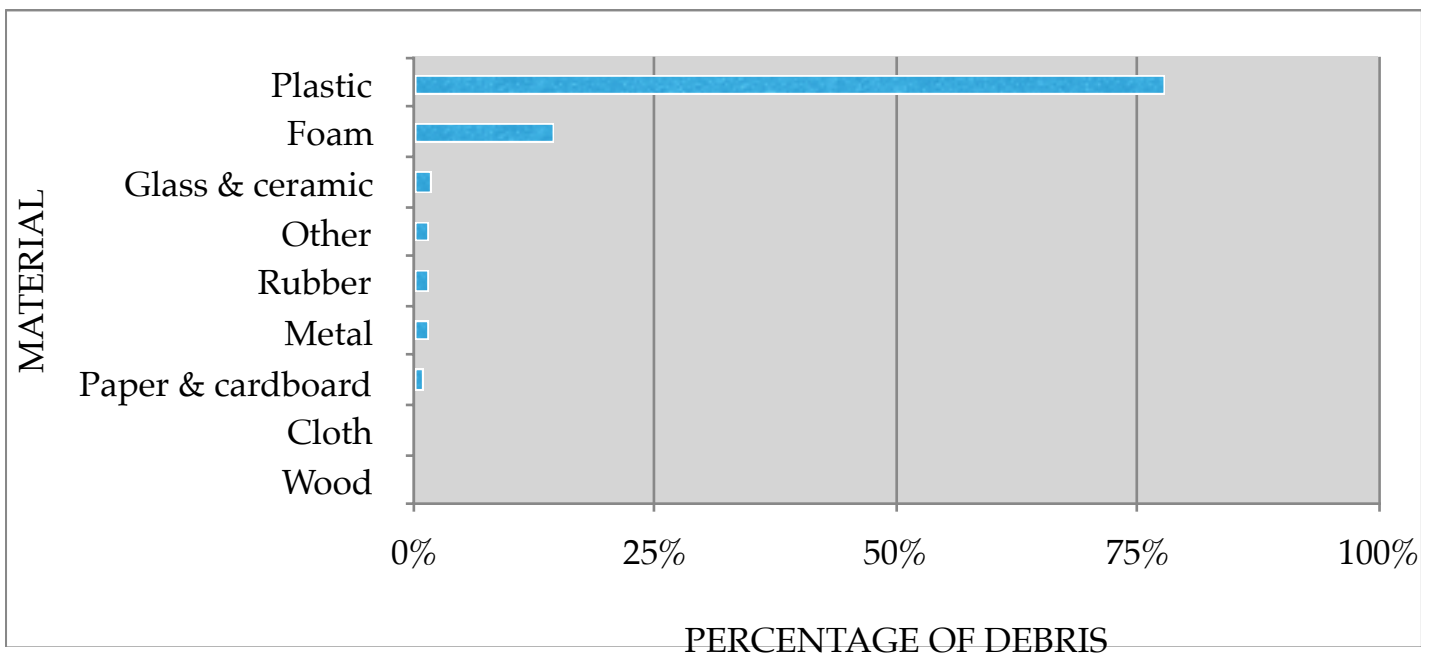
**Figure 8:** Relative proportions of categories of debris collected (Source: Tangaroa Blue Foundation, 2020)

In terms of the overall 3960 items (52kg) collected, it was found that plastic ranked the highest category of debris washed up on the river bank, including plastic food packaging, hard solid plastic, bubble wrap, plastic drink and water bottles, lids, tops, flow restrictors, plastic bags and film remnants, pens and stationary, medical syringes and electrical cables and connectors. This was followed by 573 items of foam including insulation, packaging, in whole and remnant compositions. An estimated 199 recreational fishing lines and 118 straws, cups, plates and cutlery were also recorded. Figure 9 shows the top 10 categories of debris cleaned up with 1076 cigarette butts and filters in the highest category.

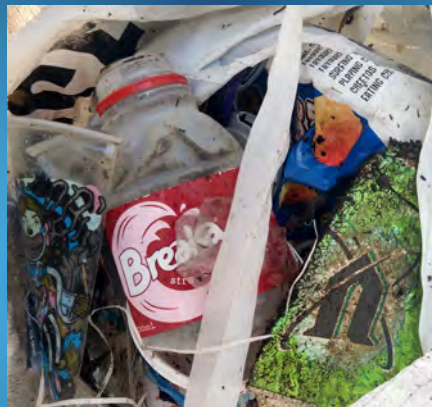
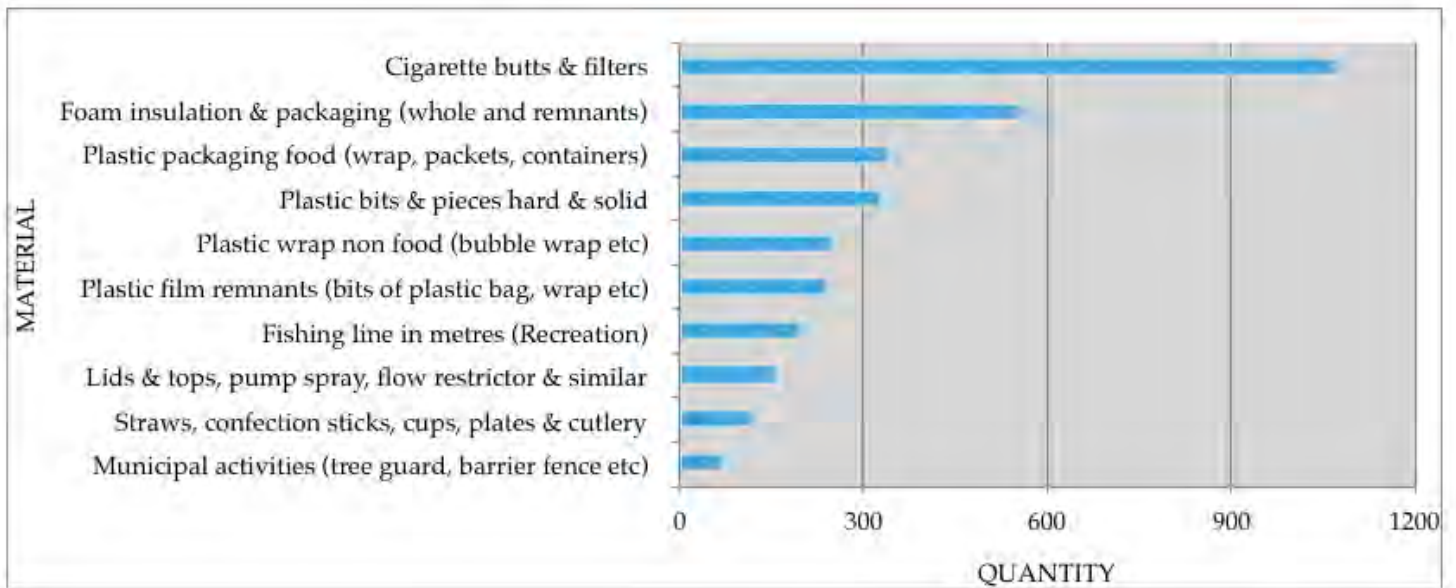
**Figure 9:** Relative proportions of categories of debris collected  
 (Source: Tangaroa Blue Foundation, 2020)
